Manhole Inspection Summary

Manhole # S11S__022MH

Insp Date: **3/28/08 8:57 AM**

Location Address: **3220 Wilkins AV**

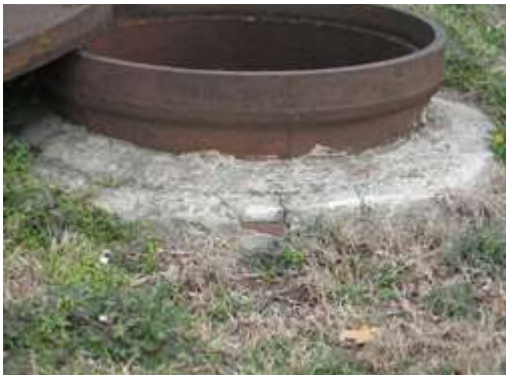
Cover Shape: **Circular** Diameter: **32** (in.) Length: **0** (in.) Dist A/B Grade: **8** (in.)

MH above grade

8 inch above grade

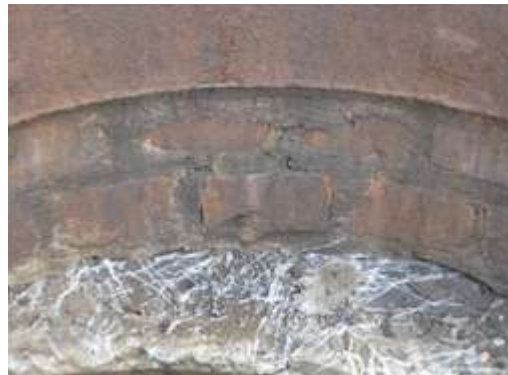
Defect 3

Infiltration: ☐ None ☐ Joint ☐ Cracks ☐ Mortar ☐ Roots ☒ **Wall**

sign of infiltration at chimney

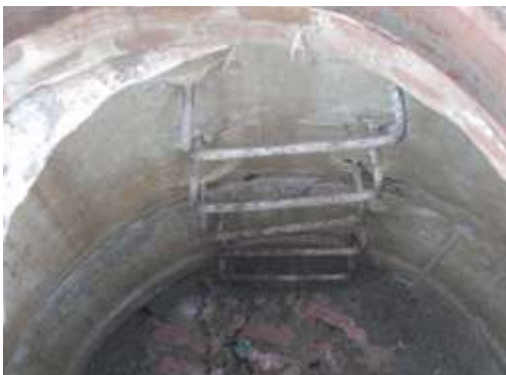
Defect 2

Condition: ☐ Sound ☒ **Cracked** ☐ Root Intrusion ☐ Loose Brick ☐ Deteriorated

cracked corbel by rungs

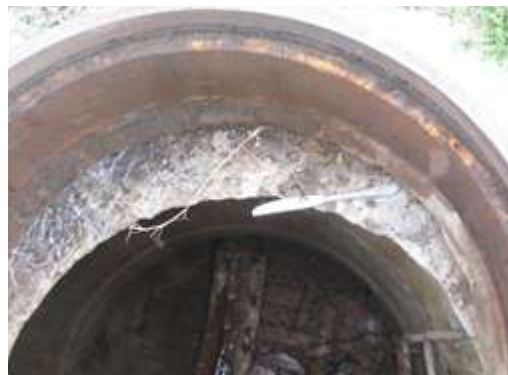
Defect 1

Frame Offset: **5** (in.) Condition: ☒ Sound ☐ Cracked ☐ Leaks

offset (5 inh)
